**MT-RAP-2008-00100/mso**

**Summary of coating surveys  
on the four air command frigates  
(Zeven Provinciën class)**

Date	March 26, 2008
Author	R. van der Kaaden, B.Sc. (TNO Quality Services B.V.)
Client	Ministry of Defence DMO / DWS / RZS / PLTFT Corrosion Prevention Attn. of Mr. H. Bakuwel, B.Sc. MPC 58 A P.O. Box 90822 2509 LV The Hague
Classification report	Unclassified
Classified by	H. Bakuwel, B.Sc.
Classification date	March 12, 2008
Title	Unclassified
Managementuittreksel	Unclassified
Abstract	Unclassified
Report text	Unclassified
Appendices	Unclassified
Copy no	18
No. of copies	22
Number of pages	40
Number of appendices	1

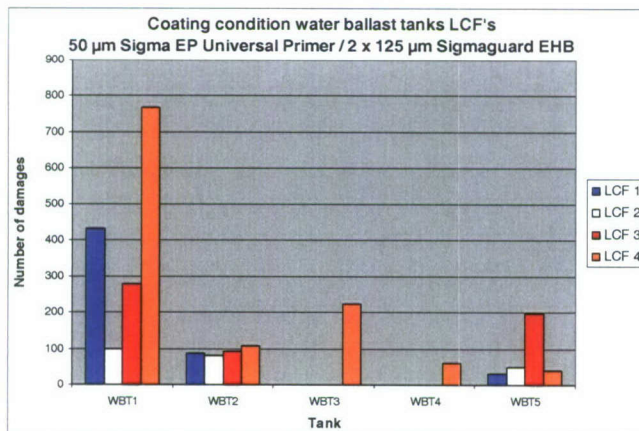
Graph 3: Number of defects in water ballast tanks

- Anodes have been mounted on a height of approx. 1 m from the deepest point in ballast tanks 1. This implies that the cathodic protection does not work when water levels are relatively low.

Results have been transformed into the following graphs showing the number of damages per tank per LCF (left) and the surface percentages affected by defects (right):

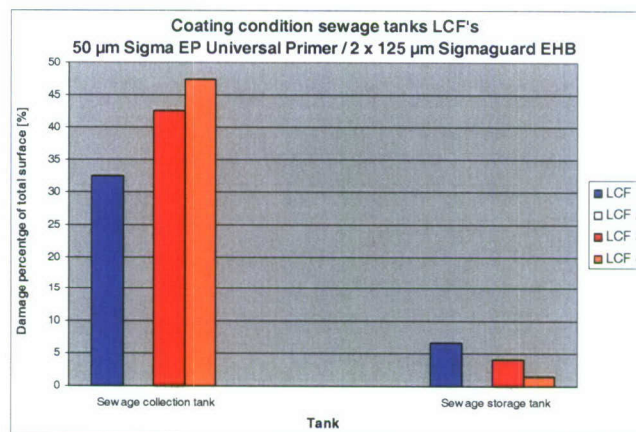
Graph 5: Affected surface percentages in sewage tanks

- Especially in the collection tanks, significant areas have been affected by blistering (photo 7). On LCF 4, the first frigate to be inspected, blistering had occurred in various places within the coating system. Subsequent inspections on LCF 1, 2 and 3 proved that blistering is a structural problem.
- Blistering has also occurred in the sewage storage tanks though to a far lesser extent.
- Both in the sewage collection and storage tank, corrosion is limited to a few spots (photo 8). As far as could be assessed, deep steel wastage has not occurred.
- The extremely poor condition of Cunifer piping in the tanks of LCF 1 (perforations) was striking (photo 9). GRP piping has been installed instead on all LCF's.

Results have been transformed into the following graph showing damage percentages:

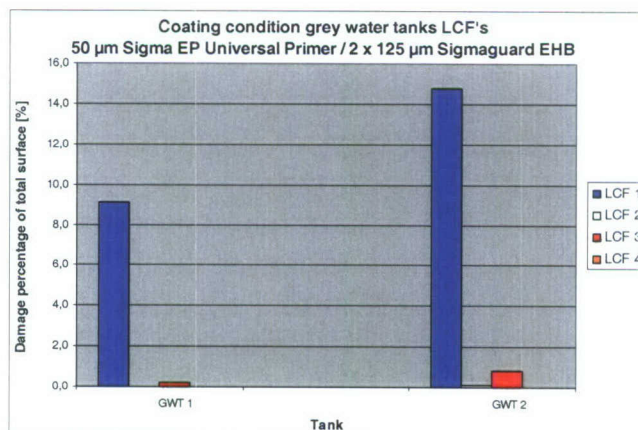
Graph 7: Affected surface percentages in grey water tanks

- Generally, the coating condition in tank 1 is significantly better compared to the condition in tank 2. This must be due to conditions inside the tanks. Grey water tank 2 is used for galley water which can be aggressive as a result of fatty acids.
- Grey water tank 2 on LCF 1 is by far in the poorest condition (photo 14). Signs of breakdown though have been observed on LCF 2 and 3 as well.
- In time the coating system in grey water tank 2 is damaged, weakened and disappears.
- Besides the general breakdown, minor damages have been a result of pores in welds, cracks in a thick coating layer and mechanical damages.
- Typically, repaired spots in grey water tank 2 on LCF 3 have developed blisters.
